NIST NCSTAR 2: Vol. I

Report of the Technical Investigation of The Station Nightclub Fire

June 2005

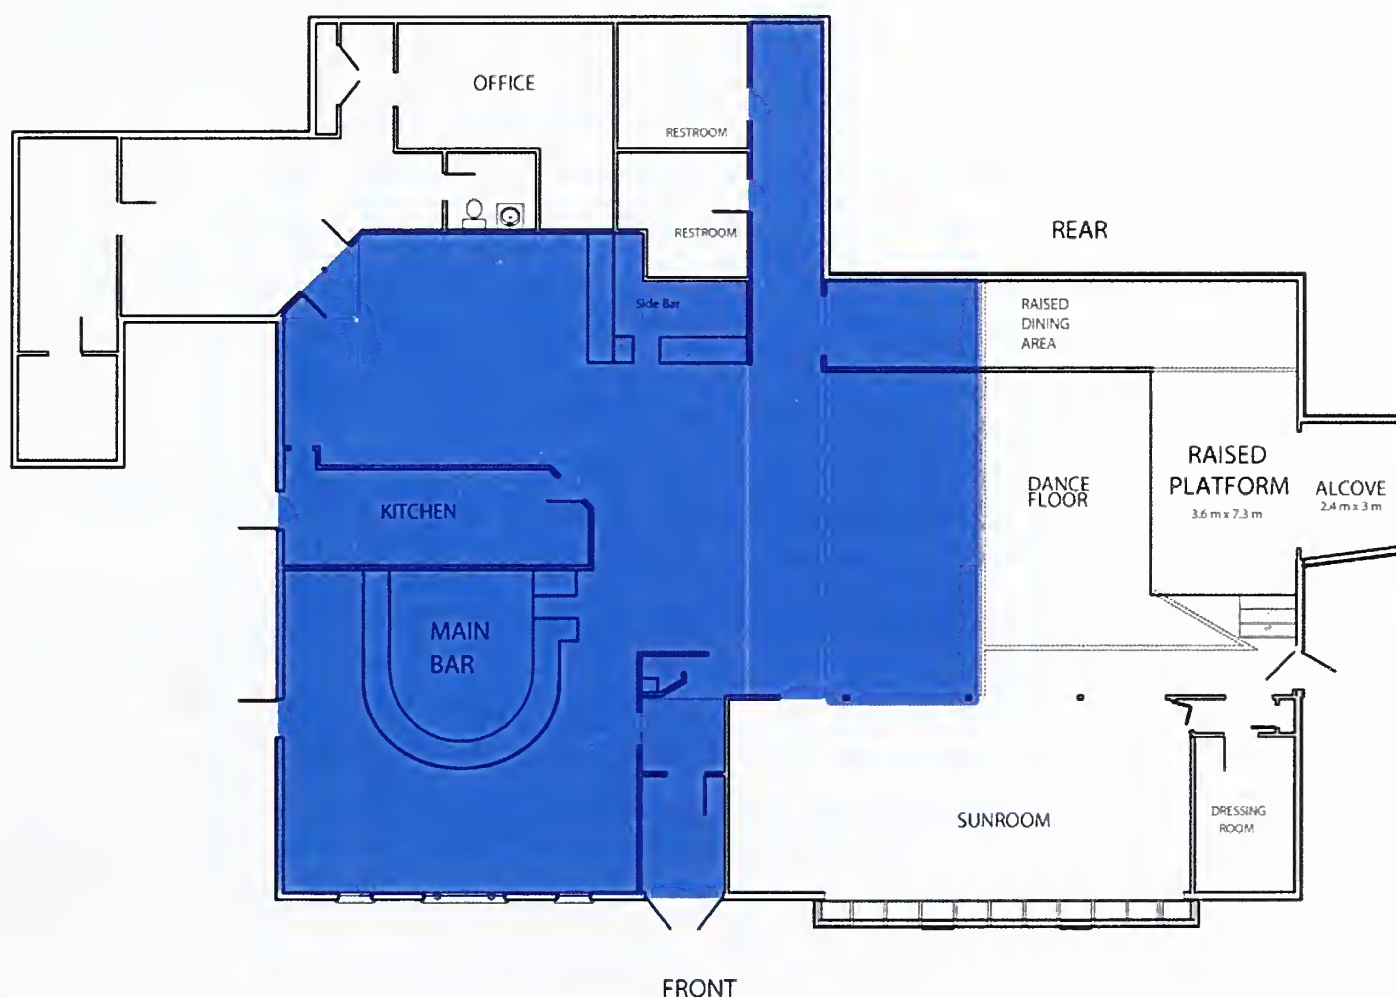
A suspended or dropped ceiling had been installed in the nightclub except for in the sunroom, the platform area, and the dance floor areas (Figure 4-3). Each 0.61 m (2 ft) x 1.22 m (4 ft) x .016 m (0.625 in) panel had been installed or dropped into a metal grid support system. Photographs of the nightclub interior clearly demonstrate that the ceiling tiles had been painted black. It was not clear from the photographs whether the paint had been applied by brush, roller, or spray can. The surface of the tiles also had a glittery appearance that may have been a result of the wet paint being dusted with glitter.

Figure 4-3. Portion of Nightclub with Acoustical Tile Ceiling (shaded blue section).

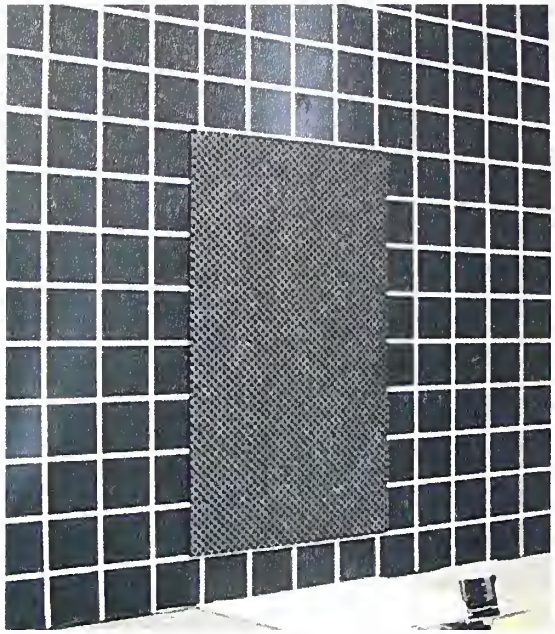
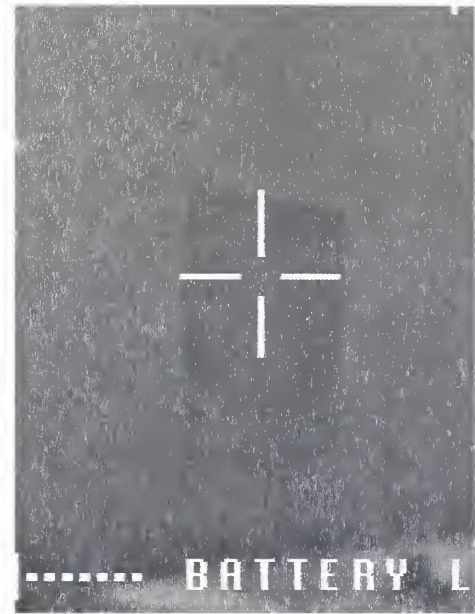
The width of the alcove in the nightclub was 3.0 m (10 ft) and the end of each gerbs was offset from the center of the opening by about one foot. The NIST tests demonstrated that a 15 x 15 gerb which was angled at 45 degrees and discharged against (and in a plane perpendicular to) a wall from a distance of 1.22 m (4 ft) could ignite a sheet of polyurethane foam in approximately 10 seconds. This is similar to the ignition sequence observed in the WPRI video.

Figure 4-13a. Standard and Infrared Video Images of Non-fire Retarded Polyurethane Foam on Gypsum Board Wall just before ignition at $t = 0$ seconds.

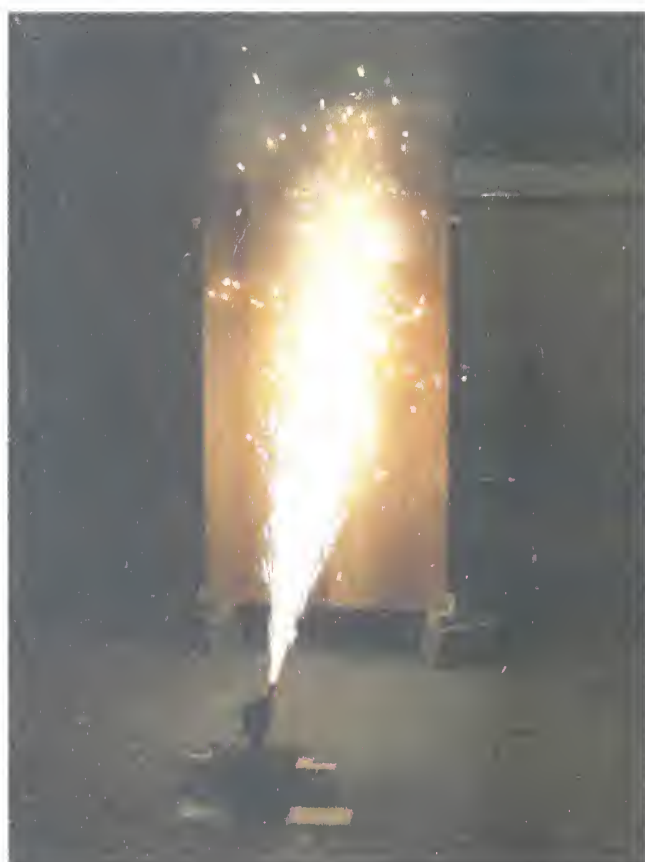
Figure 4-14a shows the sparks from the gerb impinging on the wood panel about half way through the test. No ignition was observed. The hot sparks did create small black marks and craters in the finish of the panel, as can be seen in Figure 4-14b.

Figure 4-14a. Gerb impinging on wood panel.

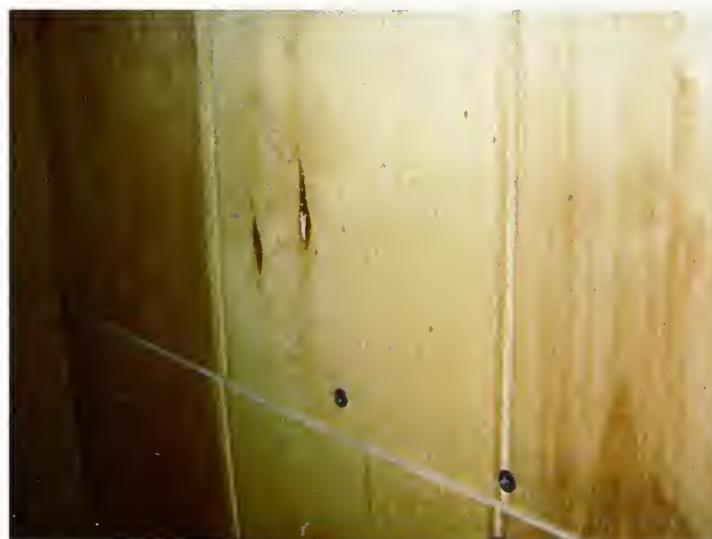
Figure 4-14b. Damage to wood panel following impingement by sparks from gerb. Lip on panel surface can be seen as line below mounting screws.
